Allied Paper, Inc./Portage Creek/ Kalamazoo River Superfund Site  
Area 3/Former Otsego Impoundment: Proposed Survey and Field Sampling Plan

Date:  
September 13, 2012

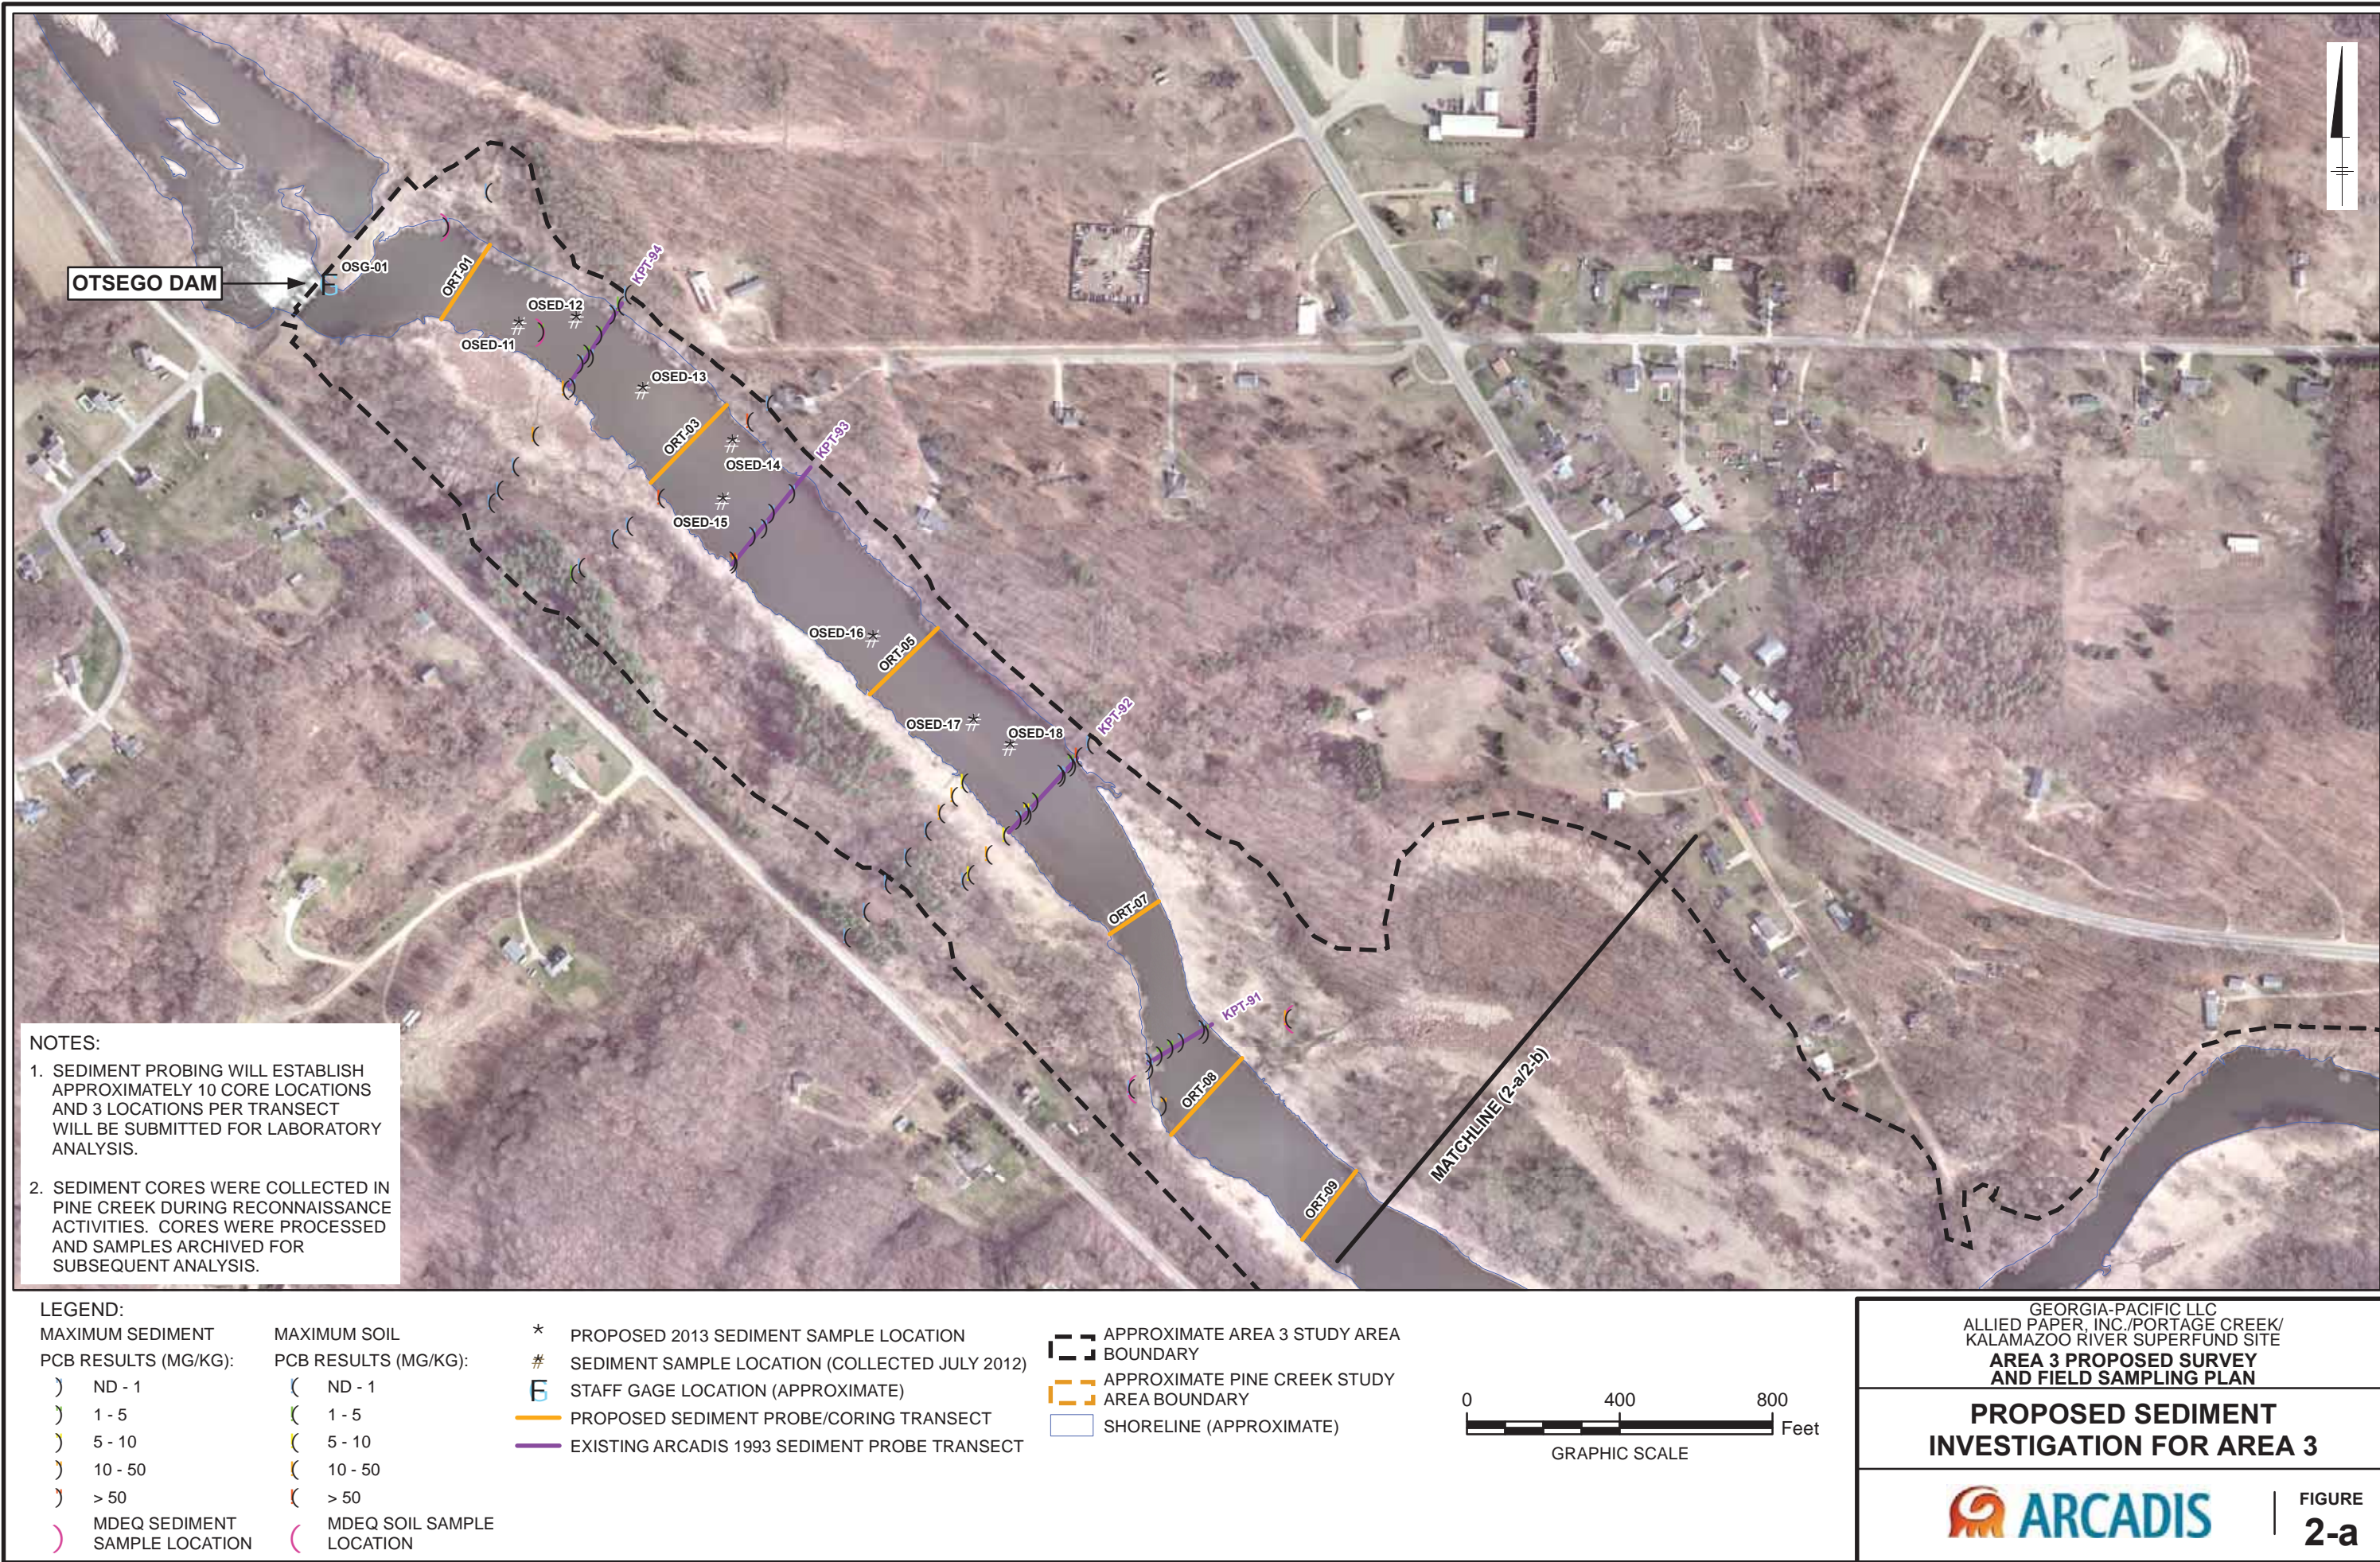
- Transects ORT-01 and ORT-08 (previously ORT-06), located between the Otsego Dam and Pine Creek, were changed from survey only transects to probing/coring transects, and ORT-08 was moved approximately 50 feet upstream (see Figures 2-a and 3-a).

- One supplemental probing/coring transect (ORT-06, previously ORT-04) was moved slightly downstream to avoid the collection of a north bank sample (OTBN-06, previously OTBN-04) on a high bank (see Figure 2-a).

Two staff gages will be installed in the impoundment, one at the Otsego Dam and one at the Lincoln Road Bridge. A previous staff gage located at the Farmer Street Bridge will also be re-established to provide readings in the upstream area of the impoundment (Figures 2-a through 2-d). The water elevation at the staff gages will be regularly monitored during field activities to capture a range of flows, and flows will be measured in conjunction with staff gage readings by recording flow velocities across the river at the Farmer Street Bridge and at the Otsego Dam to provide calibration data for modeling purposes.

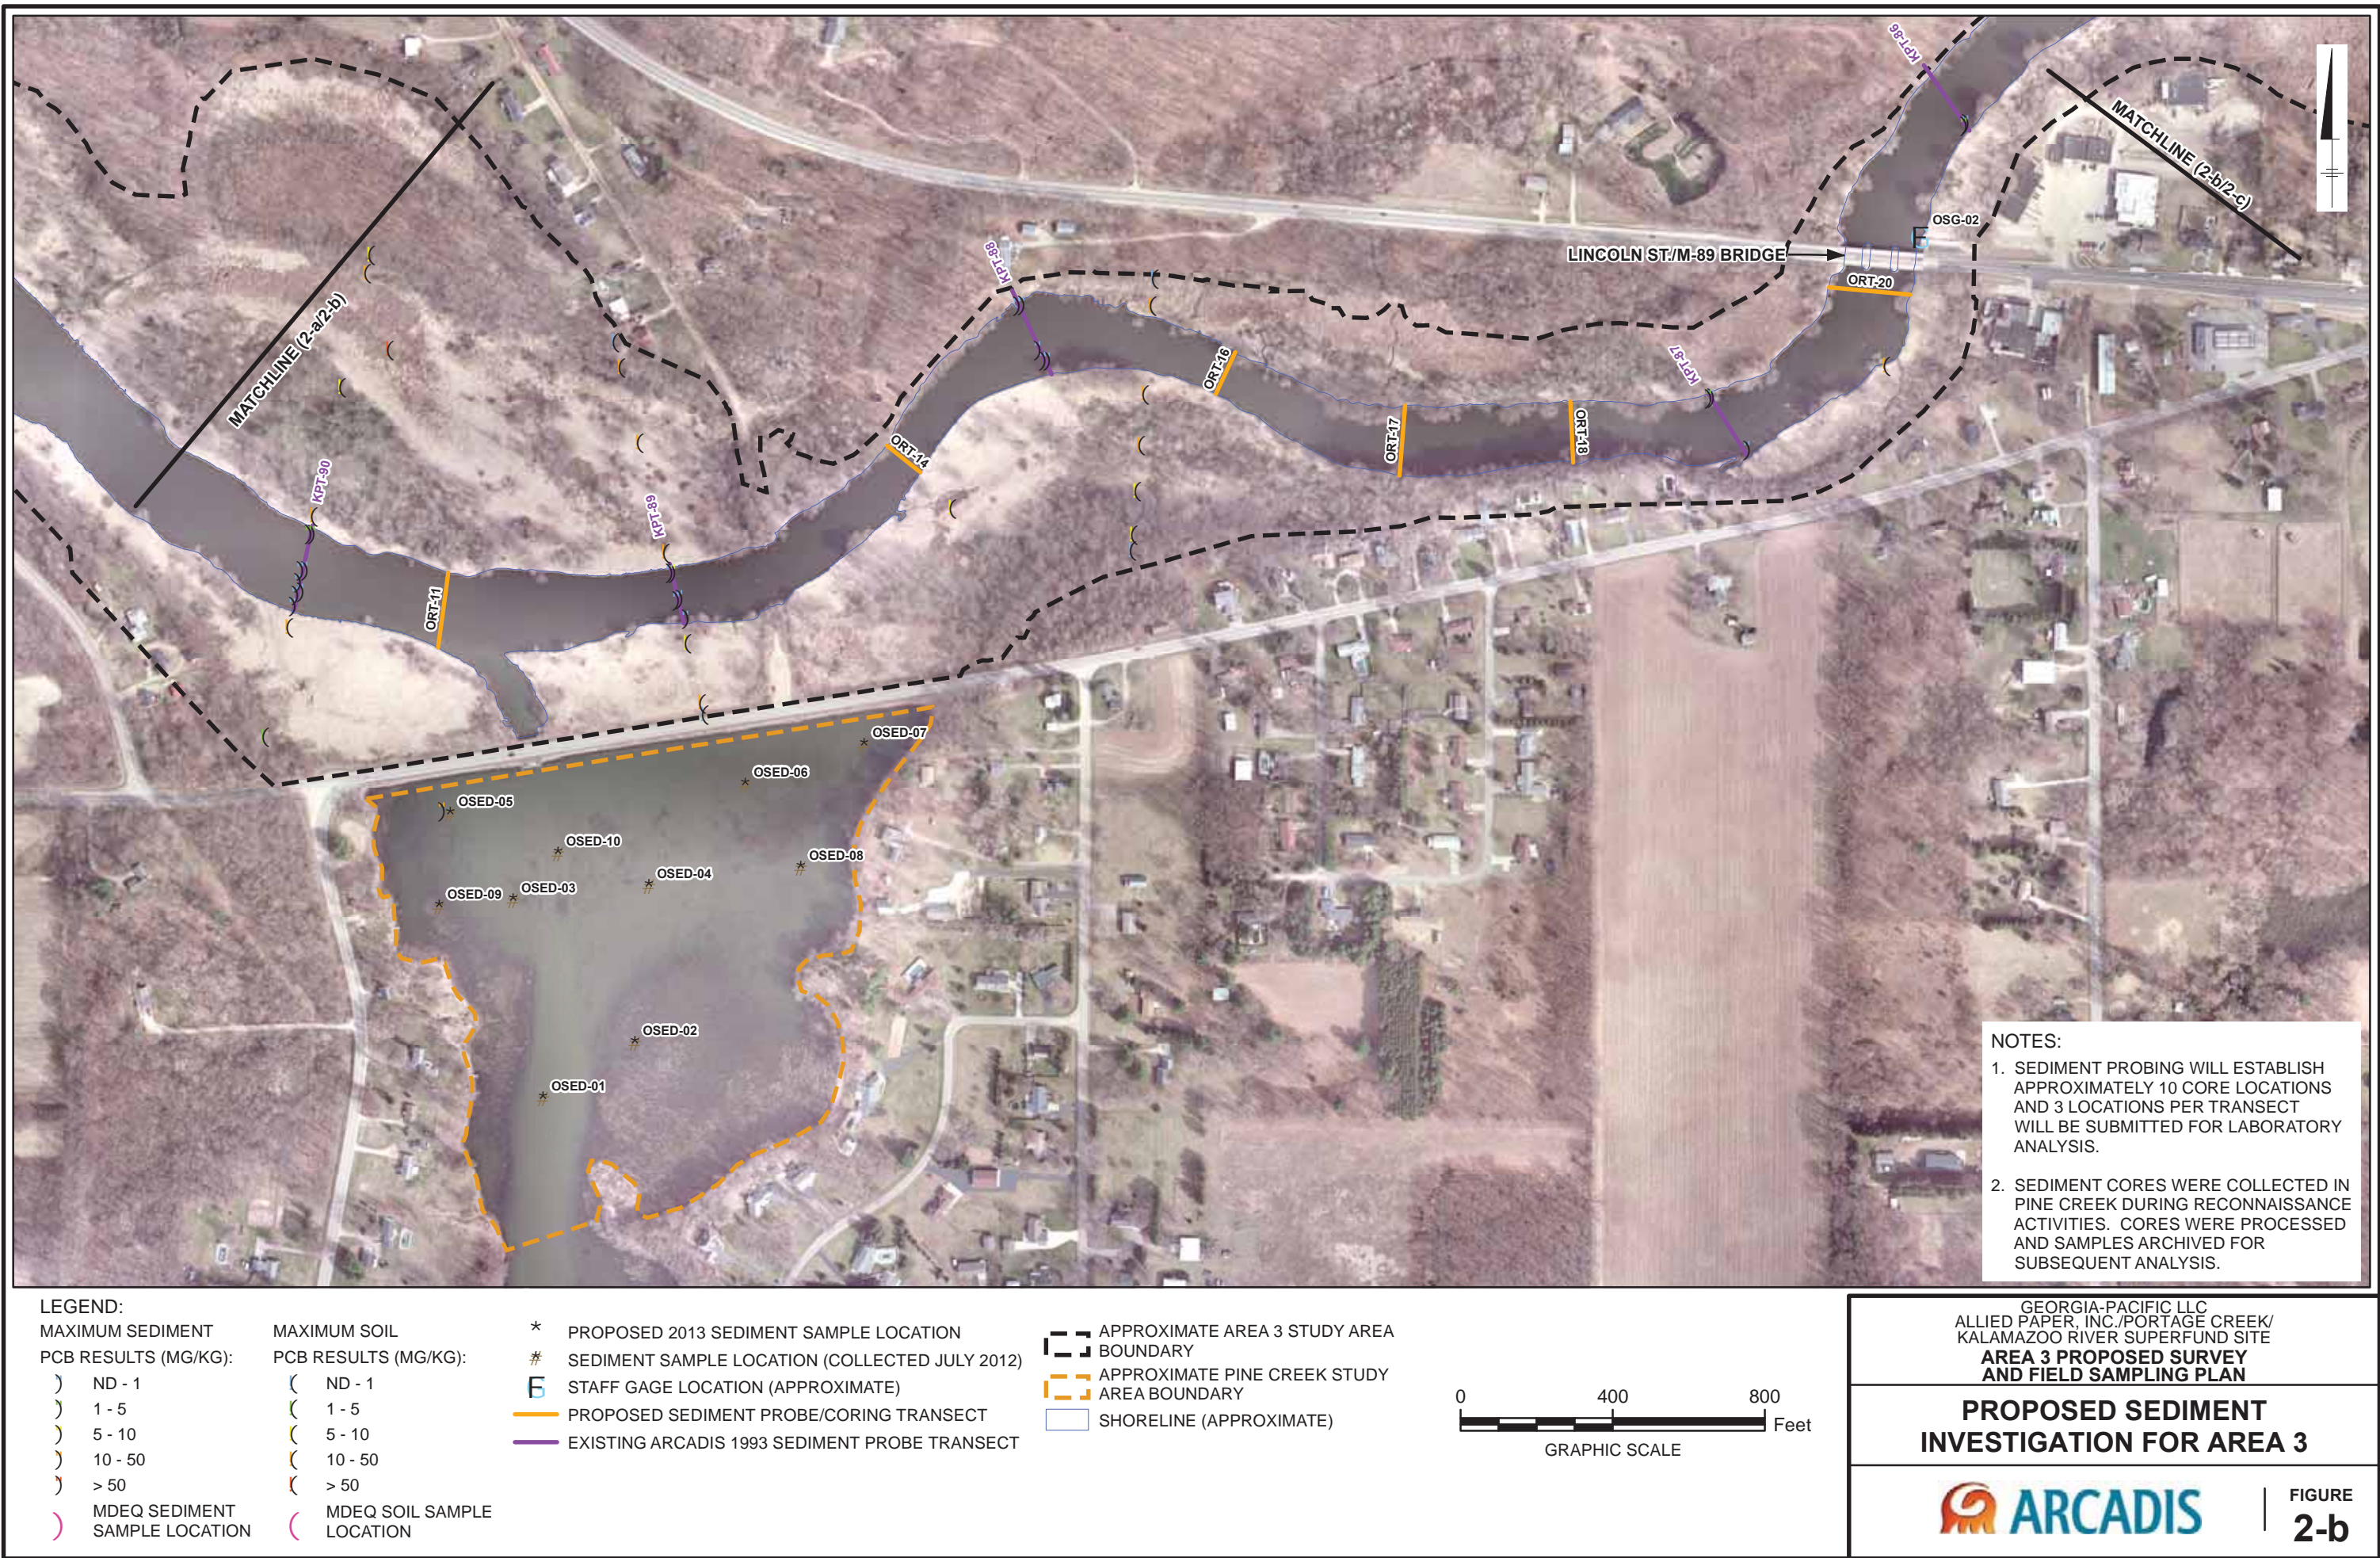
- One supplemental probing/coring transect ORT-11 (previously ORT-09) was moved downstream of the Pine Creek outlet (see Figure 2-b).
- Survey transect ORT-20 (previously ORT-16) was changed from survey only transect to probing/coring transect.

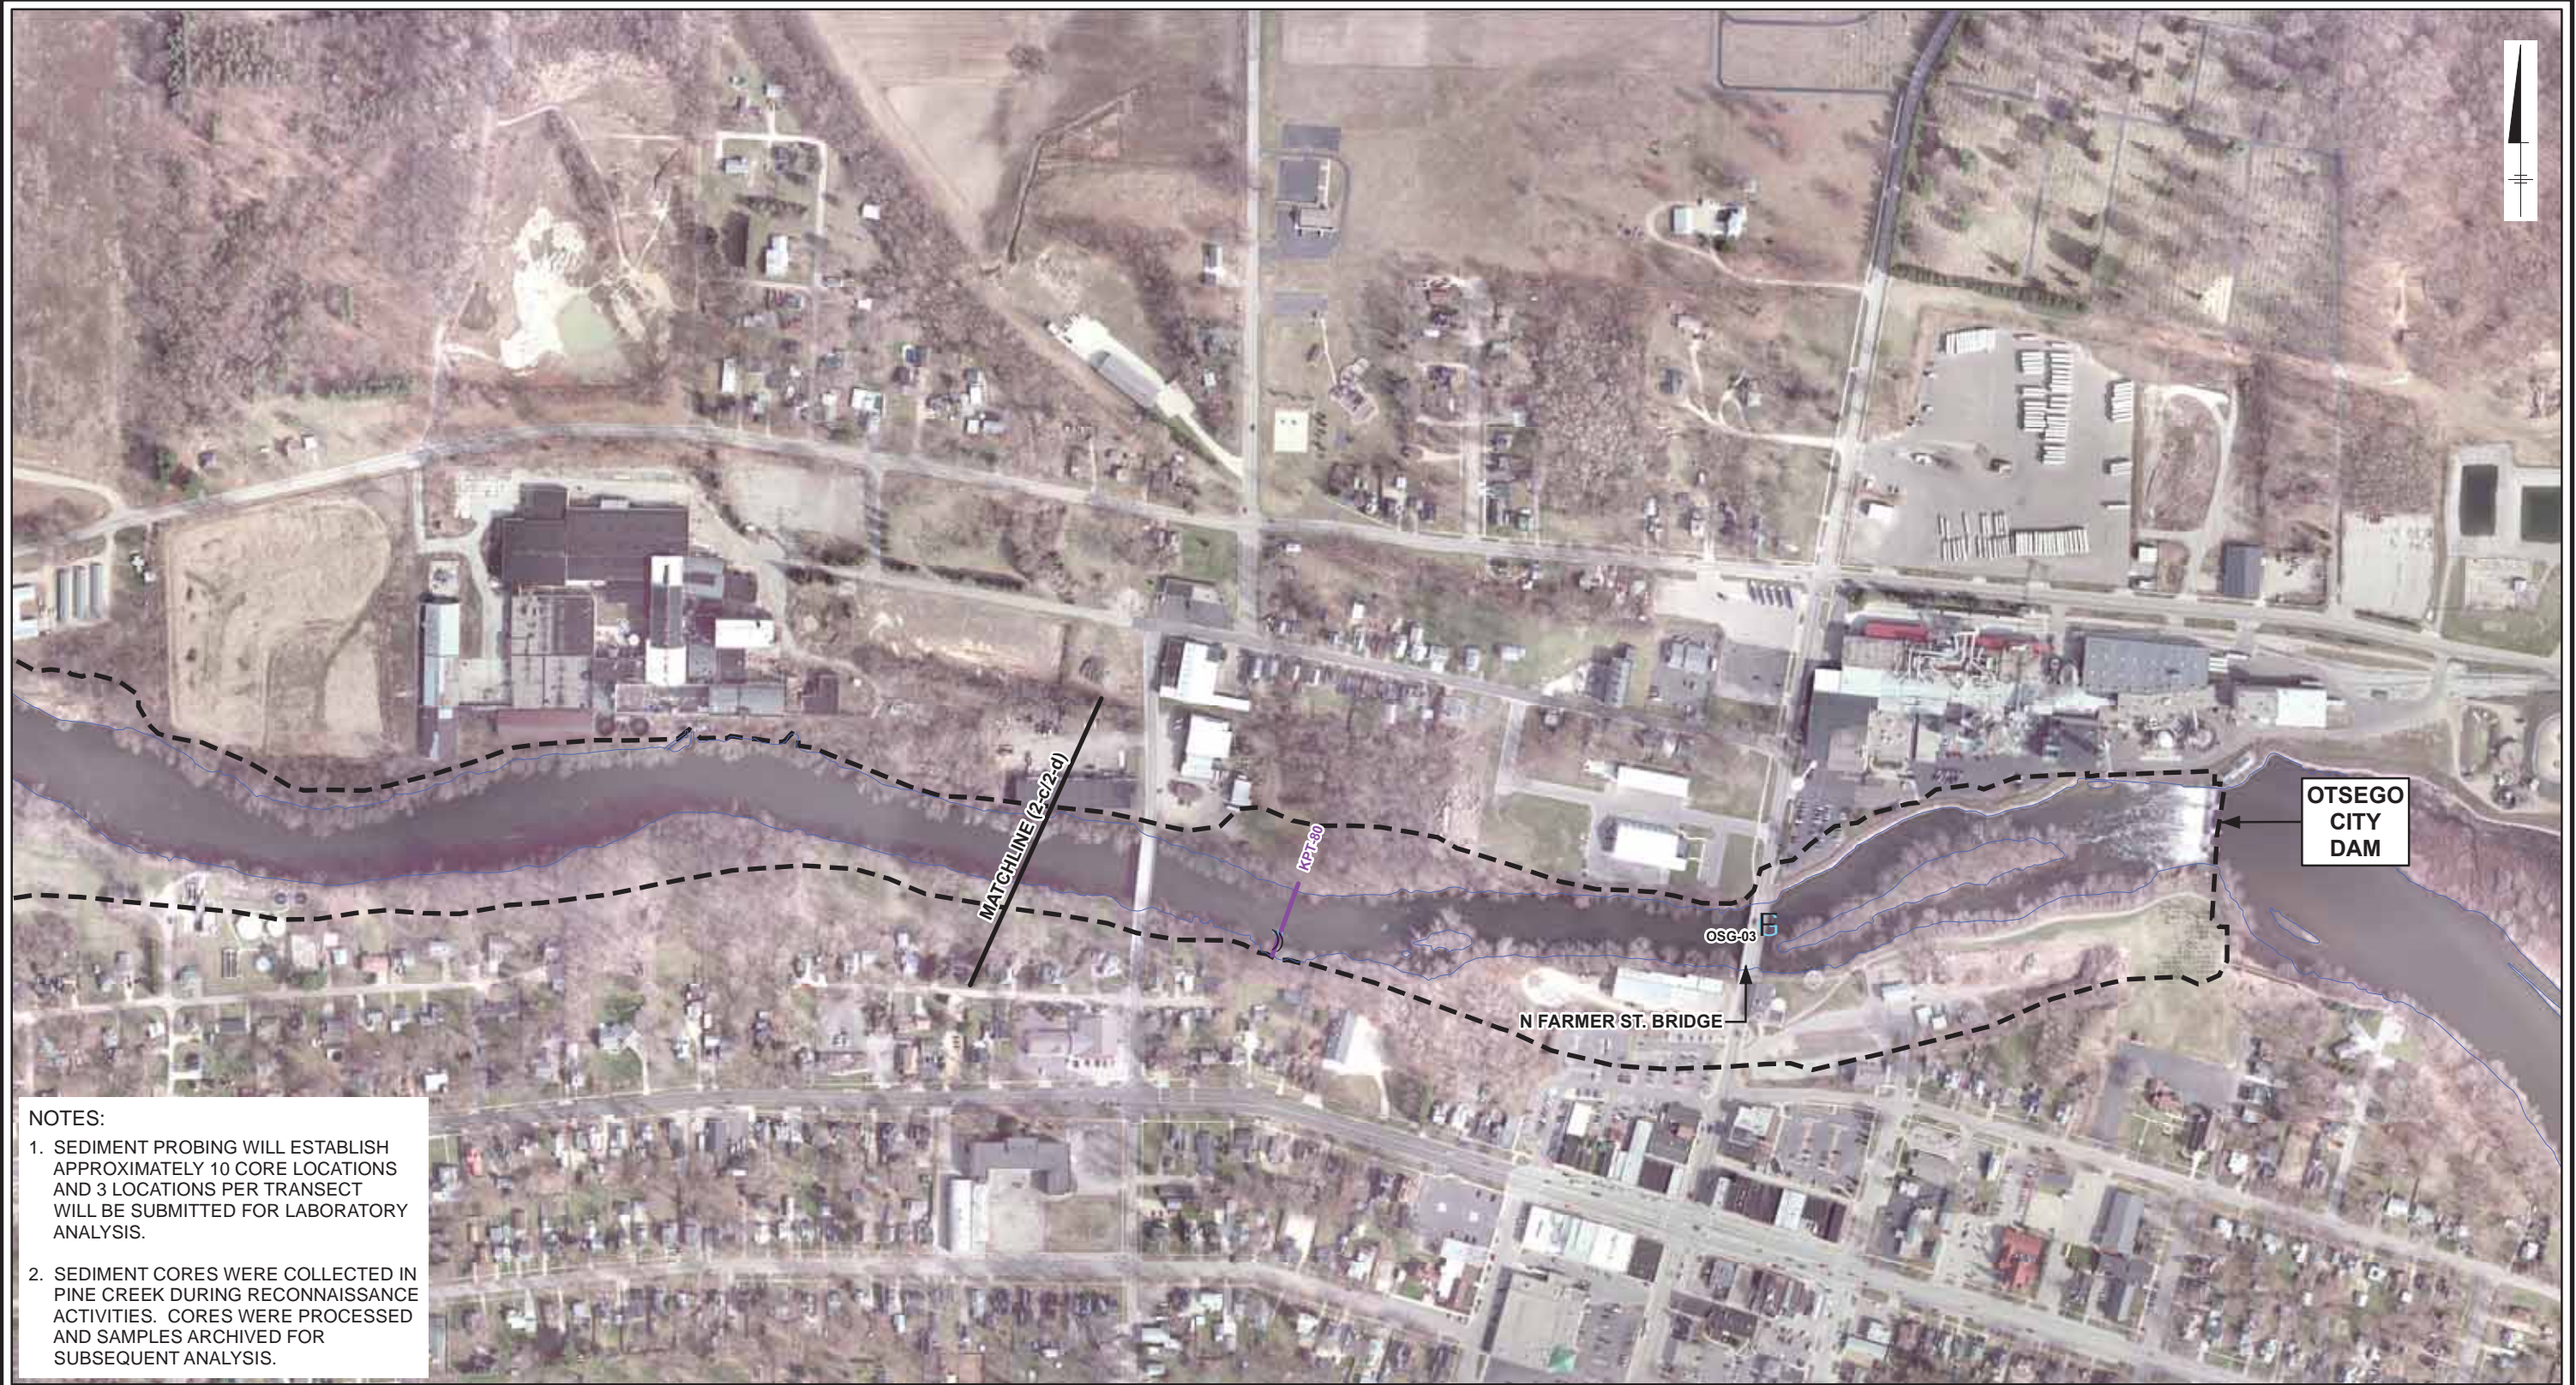
FIGURE  
**2-d**

- NOTES:
1. SEDIMENT PROBING WILL ESTABLISH APPROXIMATELY 10 CORE LOCATIONS AND 3 LOCATIONS PER TRANSECT WILL BE SUBMITTED FOR LABORATORY ANALYSIS.
  2. SEDIMENT CORES WERE COLLECTED IN PINE CREEK DURING RECONNAISSANCE ACTIVITIES. CORES WERE PROCESSED AND SAMPLES ARCHIVED FOR SUBSEQUENT ANALYSIS.

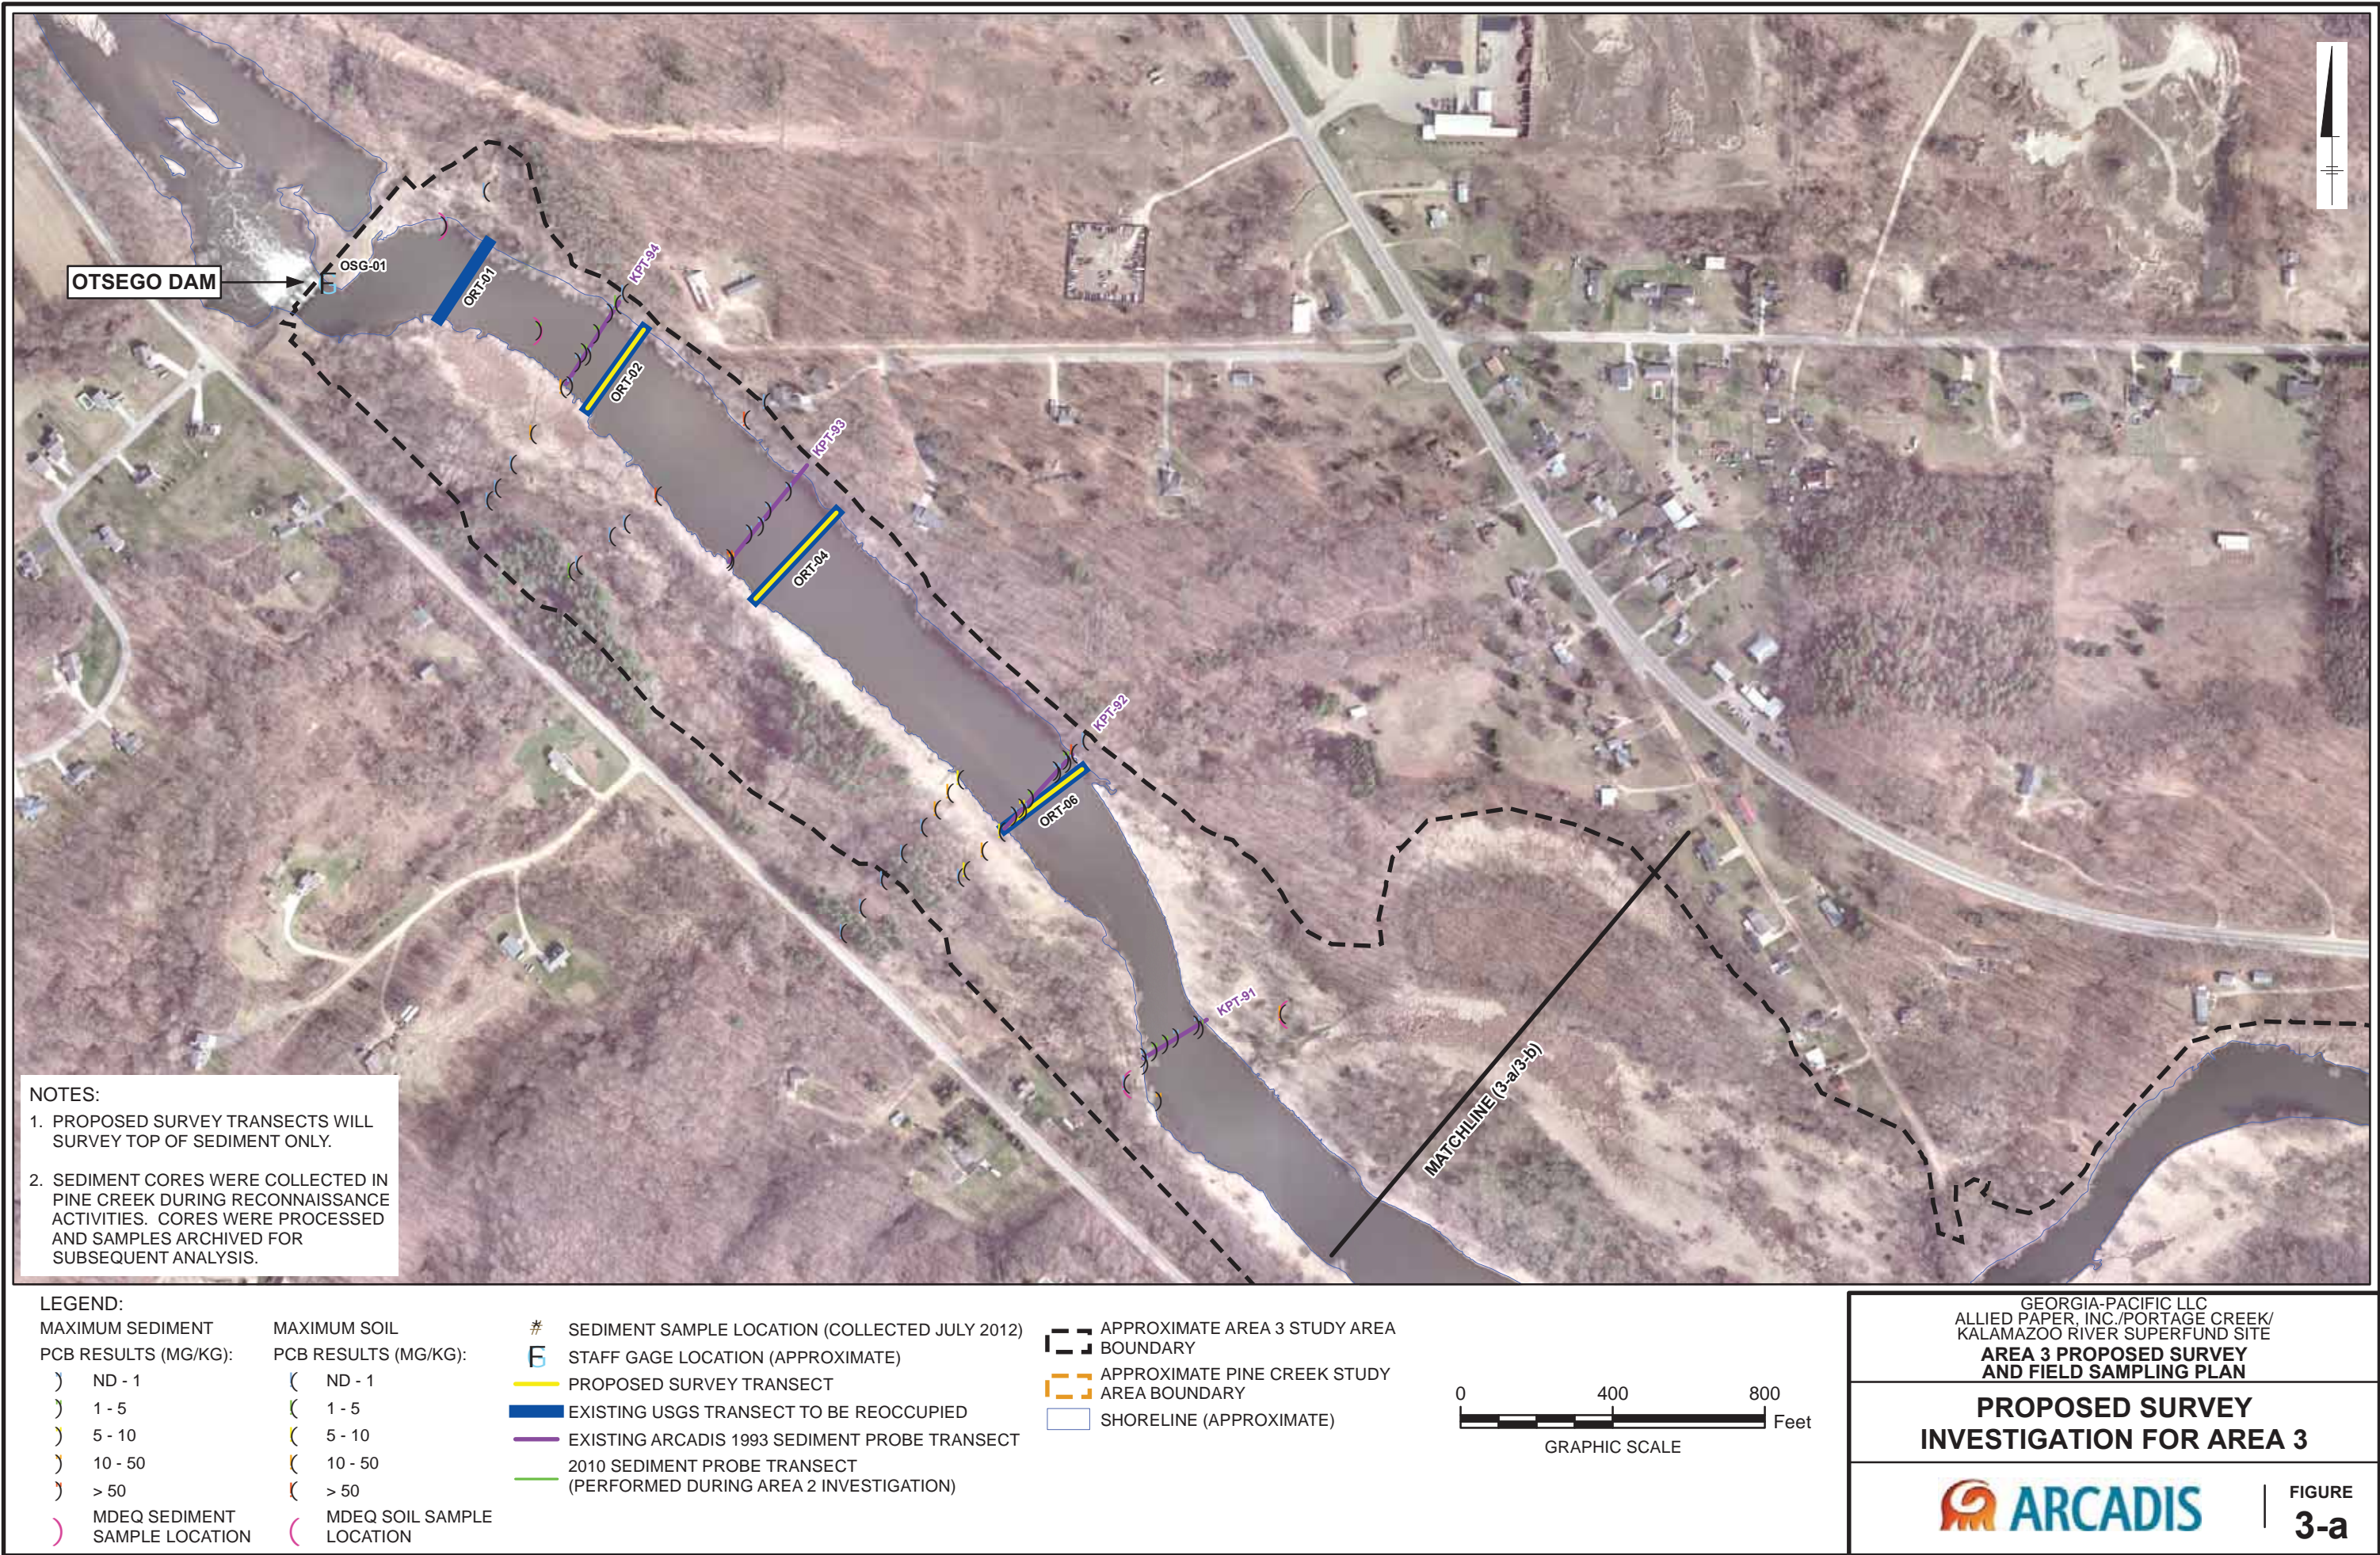
Supplemental sediment probing transects will be established at 13 locations in the Kalamazoo River upstream of the Otsego Dam (see Figure 3-a through 3-c). Along with these 13 transects, one transect previously established by USGS (USGS Transect No. 1) will be probed and sampled to further characterize sediments in the downstream area near the Otsego Dam. These transects will be positioned approximately at the mid-point between existing PCB sampling transects to essentially double the spatial resolution of the available transect sampling data. Figures 2-a through 2-d show the locations of proposed supplemental sampling transects as well as transects previously sampled by ARCADIS in 1993 and 1994.

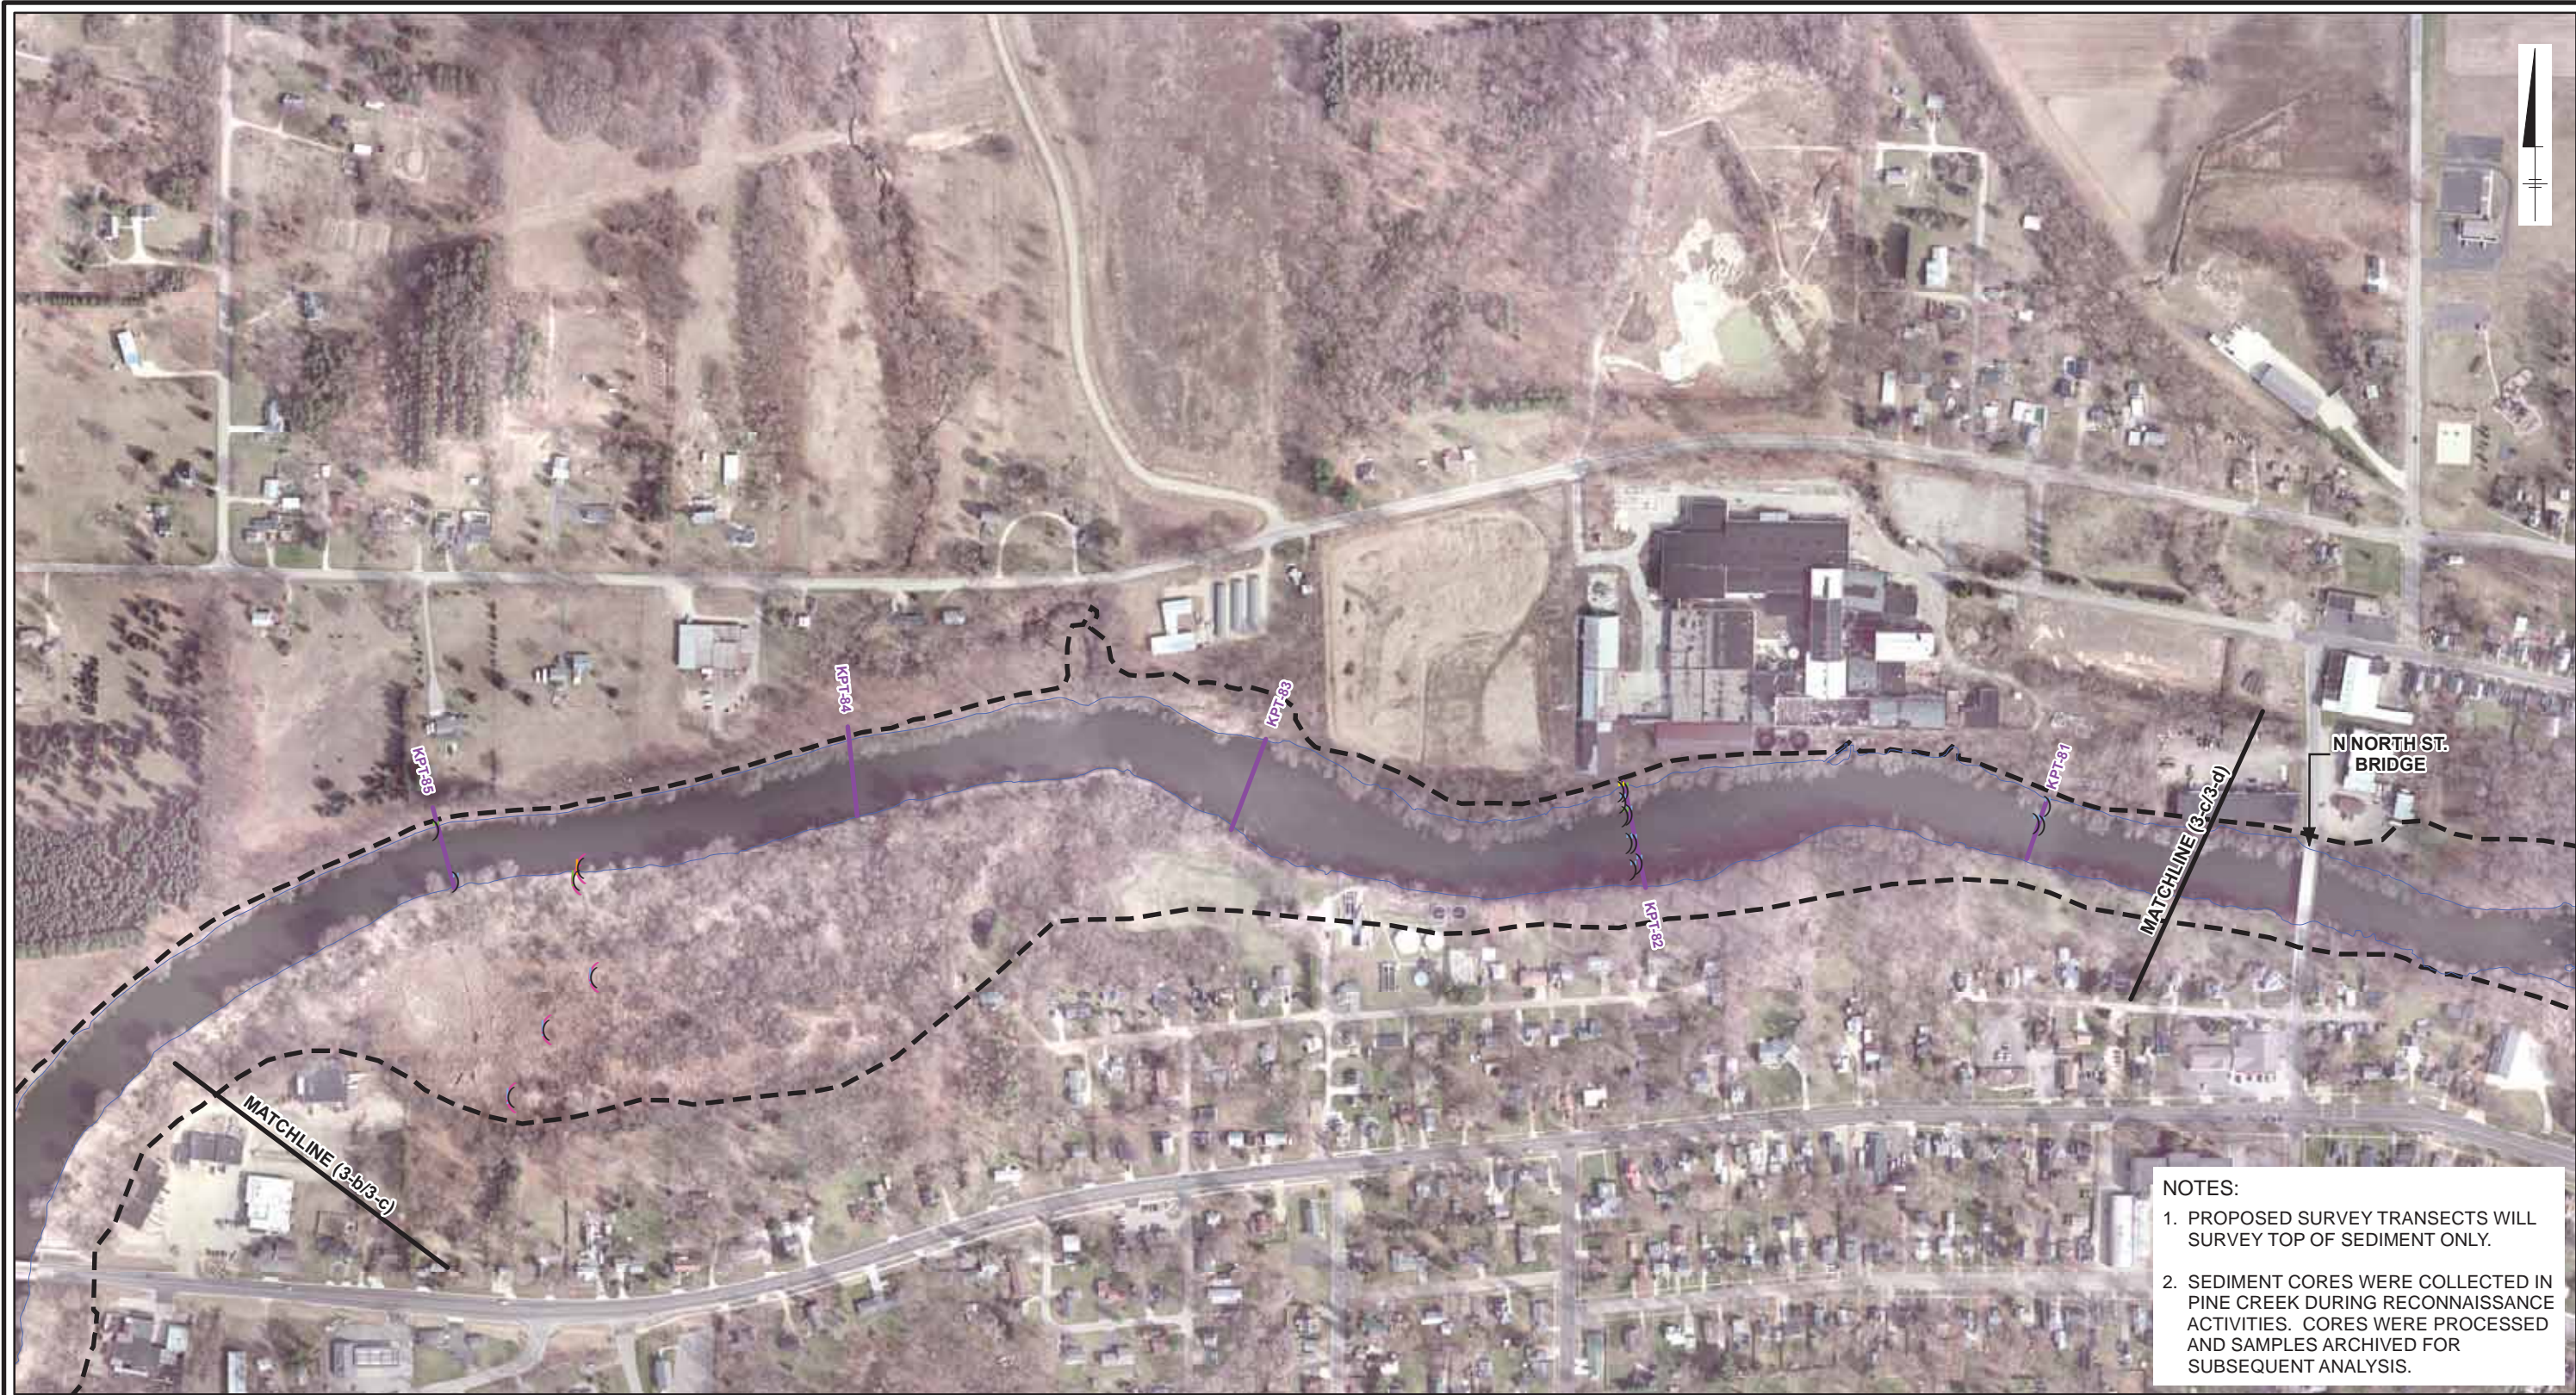
FIGURE  
**3-C**

- NOTES:
1. PROPOSED SURVEY TRANSECTS WILL SURVEY TOP OF SEDIMENT ONLY.
  2. SEDIMENT CORES WERE COLLECTED IN PINE CREEK DURING RECONNAISSANCE ACTIVITIES. CORES WERE PROCESSED AND SAMPLES ARCHIVED FOR SUBSEQUENT ANALYSIS.

In 2000, erosion pins were installed along transects at 10 locations (five locations along the north banks and five matching locations along the south river banks – see Figures 3-a through 3-d) in the former Otsego Impoundment to measure changes in the bank over time and estimate the rate of erosion, where observed. Erosion pin locations were re-surveyed twice a year through 2002 to document periodic changes in the bank that occurred during that time. Previous erosion pin survey locations will be re-established and surveyed in addition to the top-of-bank profile locations described above to update prior bank soil and PCB erosion rates presented in the 2003 Erosion Pin Monitoring Data Report (BBL 2003).

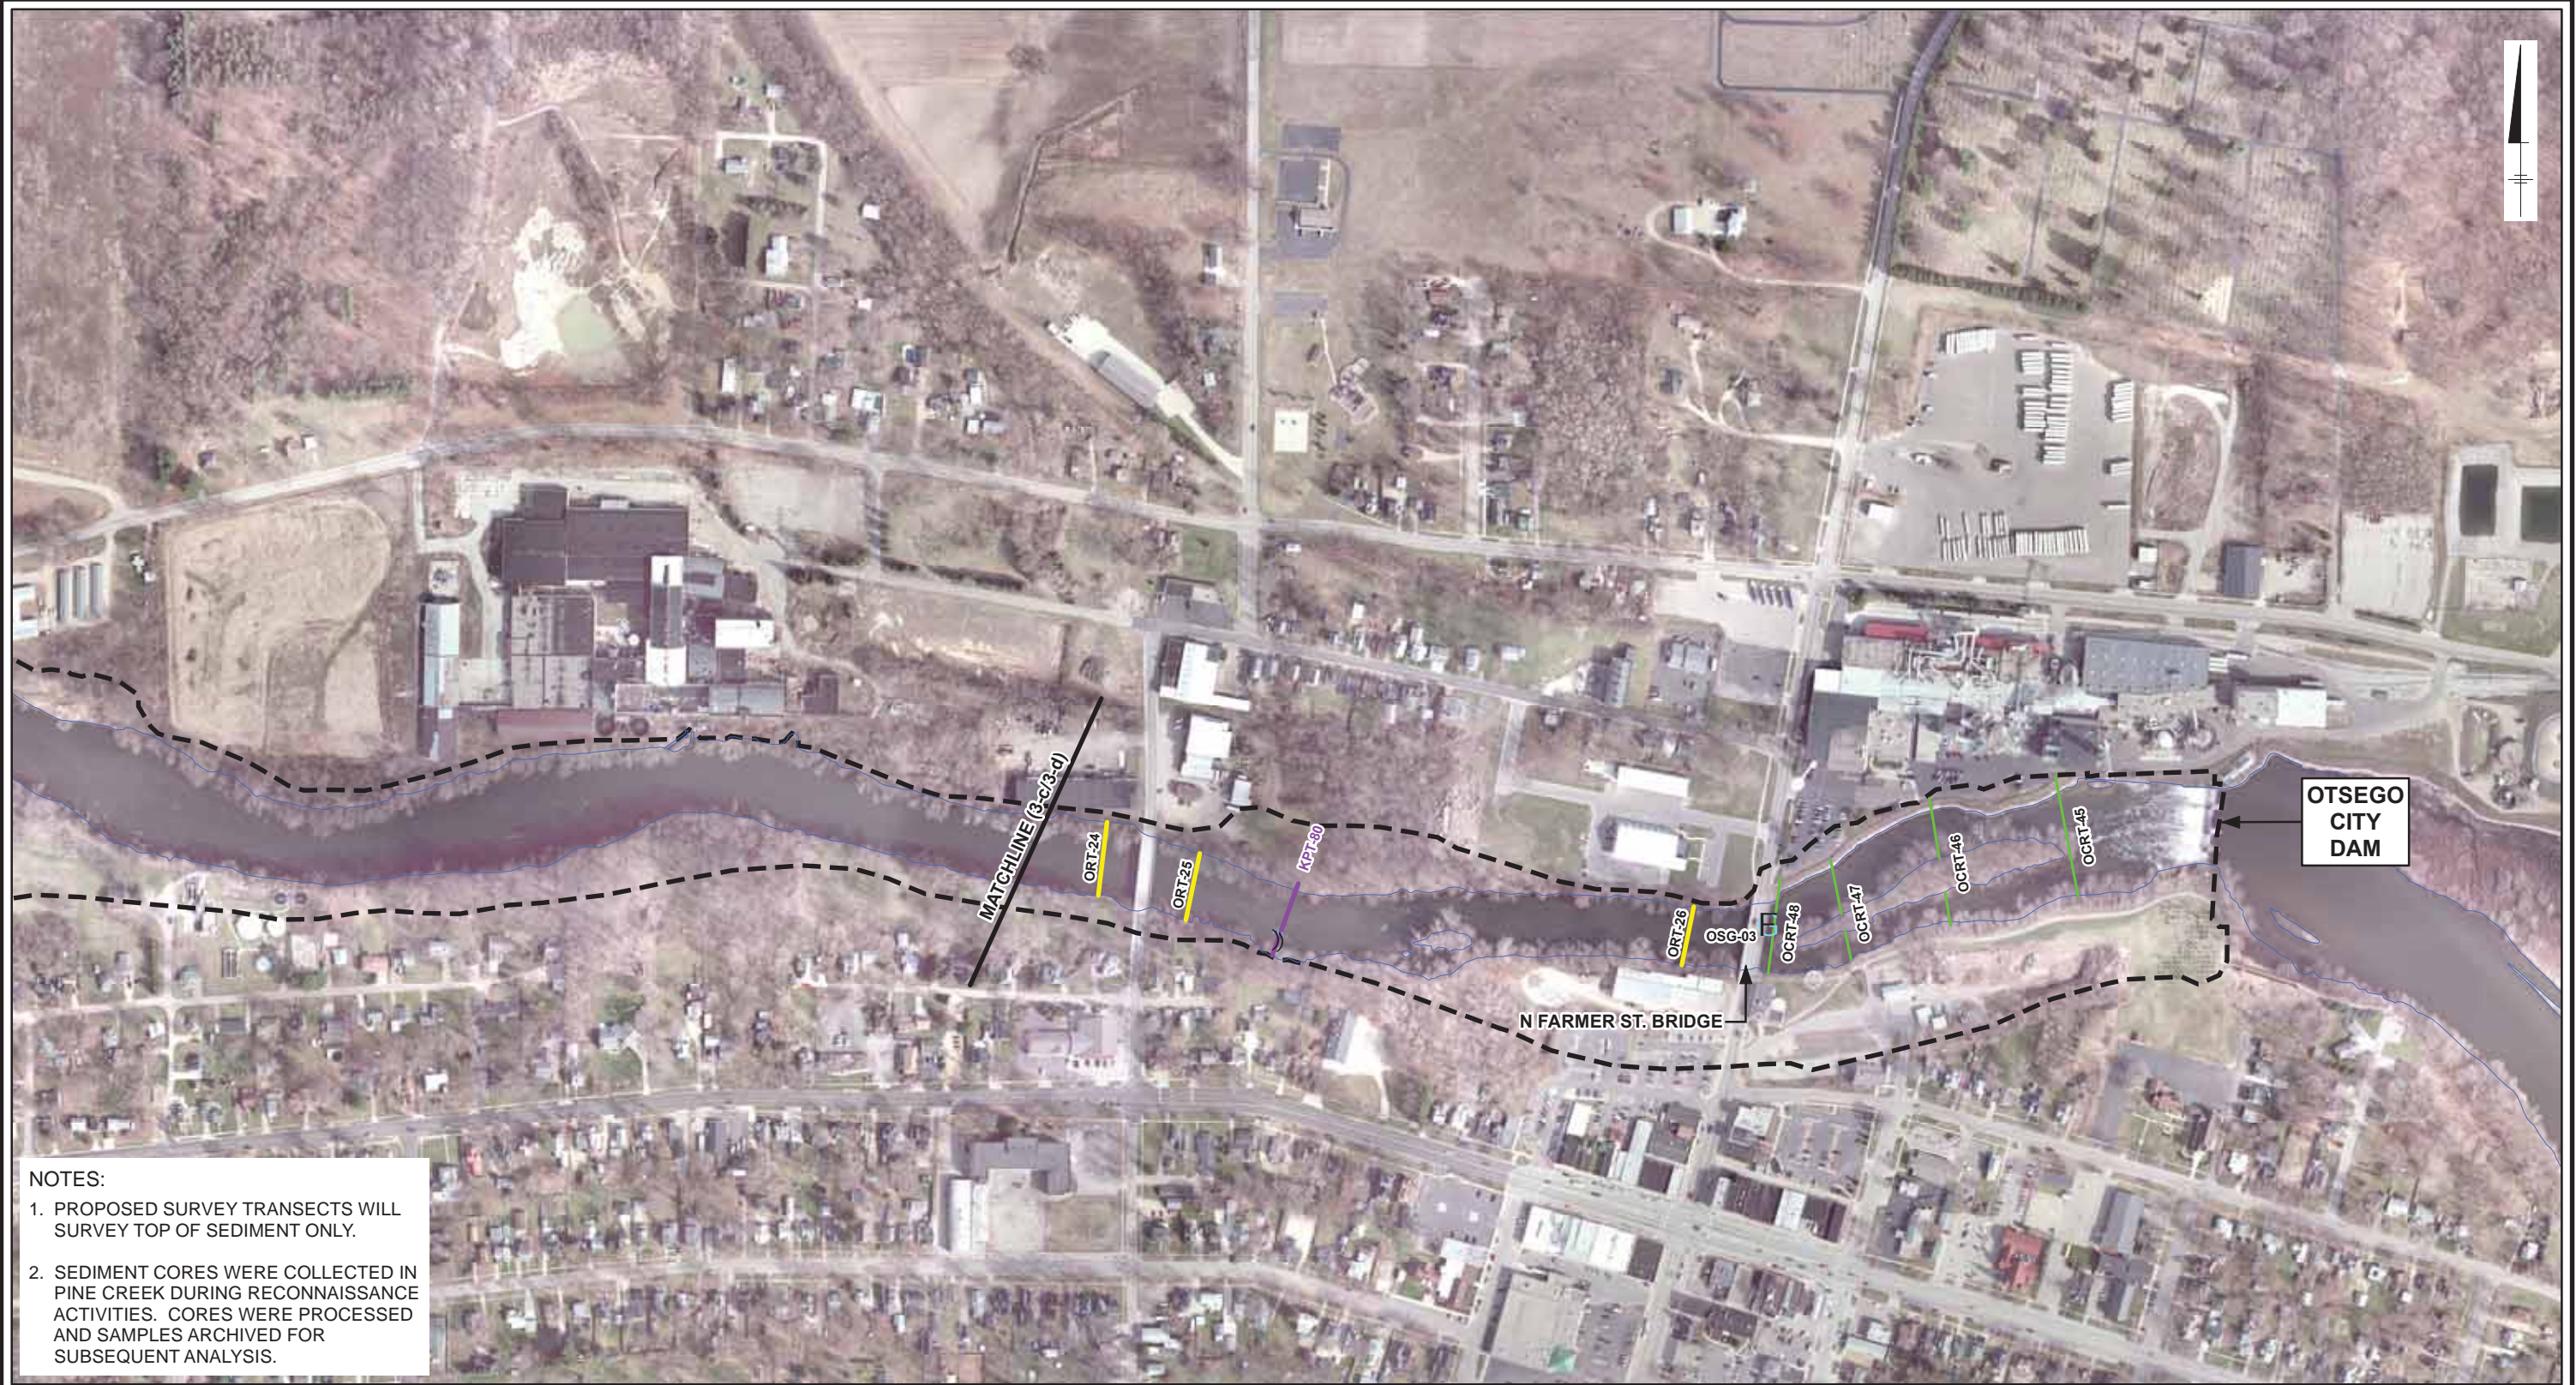
FIGURE  
**3-d**

1. PROPOSED SURVEY TRANSECTS WILL SURVEY TOP OF SEDIMENT ONLY.
2. SEDIMENT CORES WERE COLLECTED IN PINE CREEK DURING RECONNAISSANCE ACTIVITIES. CORES WERE PROCESSED AND SAMPLES ARCHIVED FOR SUBSEQUENT ANALYSIS.
